Hurricane Reroofs

Post Hurricane Ike & Katrina Roof Renovations

by Mark Strait, president, Kirsch Building Products

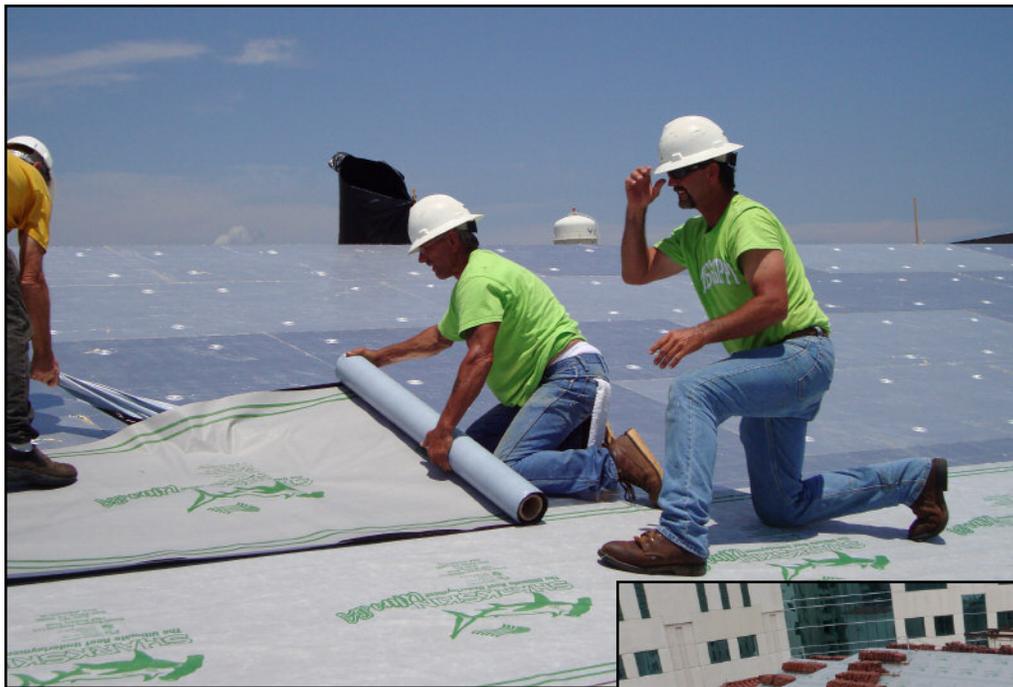
LEFT, WORKERS ROLL OUT SHARKSKIN UNDERLAYMENT AT THE KEESLER AIR FORCE BASE, BILOXI, MISS. BELOW, AN OVERVIEW OF THE HERMAN MEMORIAL HOSPITAL PROJECT IN HOUSTON, TEXAS.

Keesler Air Force Base

and roof systems, which include high-wind-rated mechanically fastened insulation system and premium roof underlayments. A new Fire Crash Rescue building was built to replace the existing facility damaged by the hurricane. A Fabral standing seam 24-gauge, 16" coverage by 2½" depth panel, Kynar coated with a dark bronze color was chosen along with Sharkskin Ultra SA for its high temp rating, 12-month UV exposure rating, and the labor saving installation features and benefits in using a light weight 48" x 125' / 5 square roll.

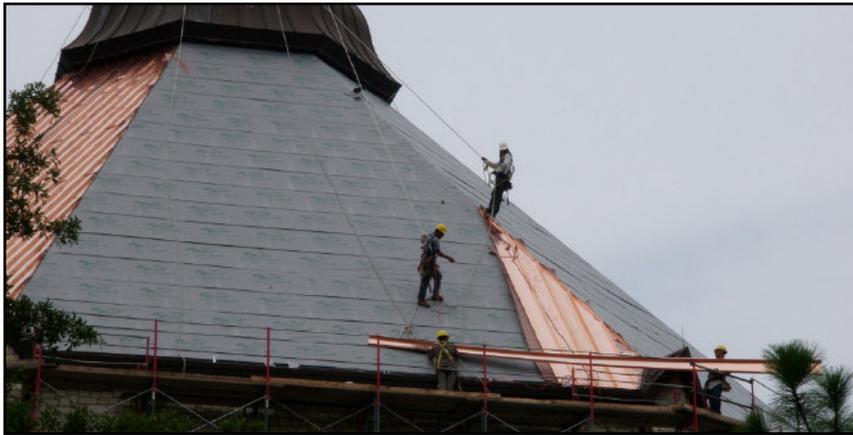
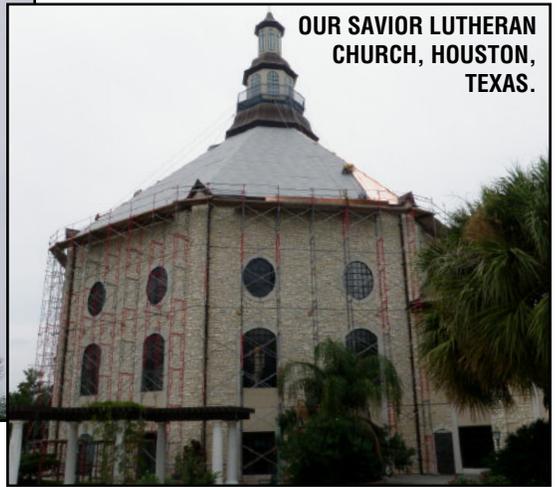
OUR SAVIOR LUTHERAN CHURCH, HOUSTON, TEXAS.

The Our Savior Lutheran Church, Houston, Texas, was compromised by Hurricane Ike just eight years after being built when the synthetic slate roof was peeled off and damaged. After the storms, a roofing contractor was hired to install a hurricane resistant roof system with long-term service life.

A custom-made 20-oz. standing seam copper roof system was selected. Since the copper panels would need to be fabricated, transported, and loaded onto the church roof, the roof underlayment would potentially

be exposed for a long period of time to the elements. In addition the contractor wanted a self-adhered roof underlayment that would bond well to the original SBS peel and stick roof underlayment and serve as a slip sheet for the 20-oz copper standing seam used to recover the church dome. While researching options, the contractor found that Sharkskin Ultra SA, a self-adhered synthetic underlayment that could be left exposed for up to 12 months, provides a high temp rating under the copper roof, and is slip-resistant even when wet. The Sharkskin Ultra SA
